**PITTING CORROSION AND SURFACE CHEMICAL
PROPERTIES OF A THIN OXIDE LAYER ON
ANODIZED ALUMINUM ALLOYS**

TECHNICAL REPORT AFML-TR-78-128
Final Report for Period June 1977 to May 1978

AIR FORCE MATERIALS LABORATORY
AIR FORCE WRIGHT AERONAUTICAL LABORATORIES
AIR FORCE SYSTEMS COMMAND
WRIGHT-PATTERSON AIR FORCE BASE, OHIO 45433

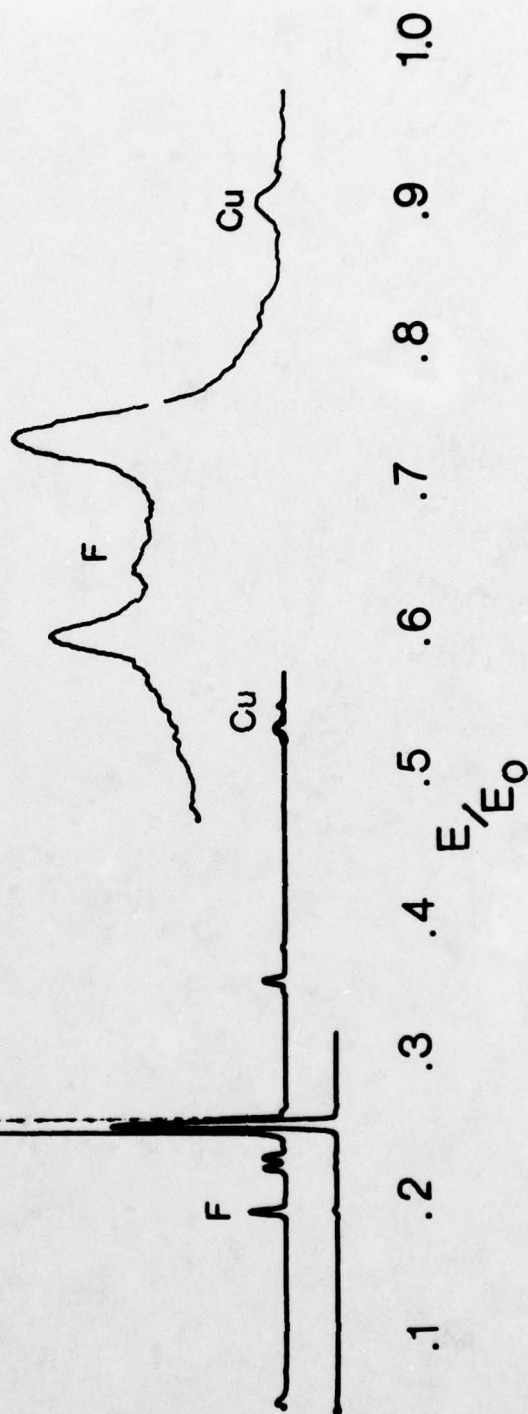
Figure 1. SIMS-ISS Spectrum of Phosphoric Anodized 2024 Specimen

Wood (Reference 5) has reported on the incorporation of alloying elements in the anodic oxide layer of thick ($50\text{ }\mu\text{m}$) films. Our studies (Reference 6) on thin anodic oxide films show the same general trend where alloying elements become part of the growing oxide film. We can see some of these effects in Figure 1 where a HNO_3 -HF treated surface of 2024Al was anodized for 60 seconds in H_3PO_4 . This oxide film is approximately $0.05\text{ }\mu\text{m}$ thick, but the elements fluorine and copper are still detected by SIMS and ISS. Since these chemical inhomogenities can exist throughout the oxide film it is necessary to know if they can be responsible for breakdown of the passive film.

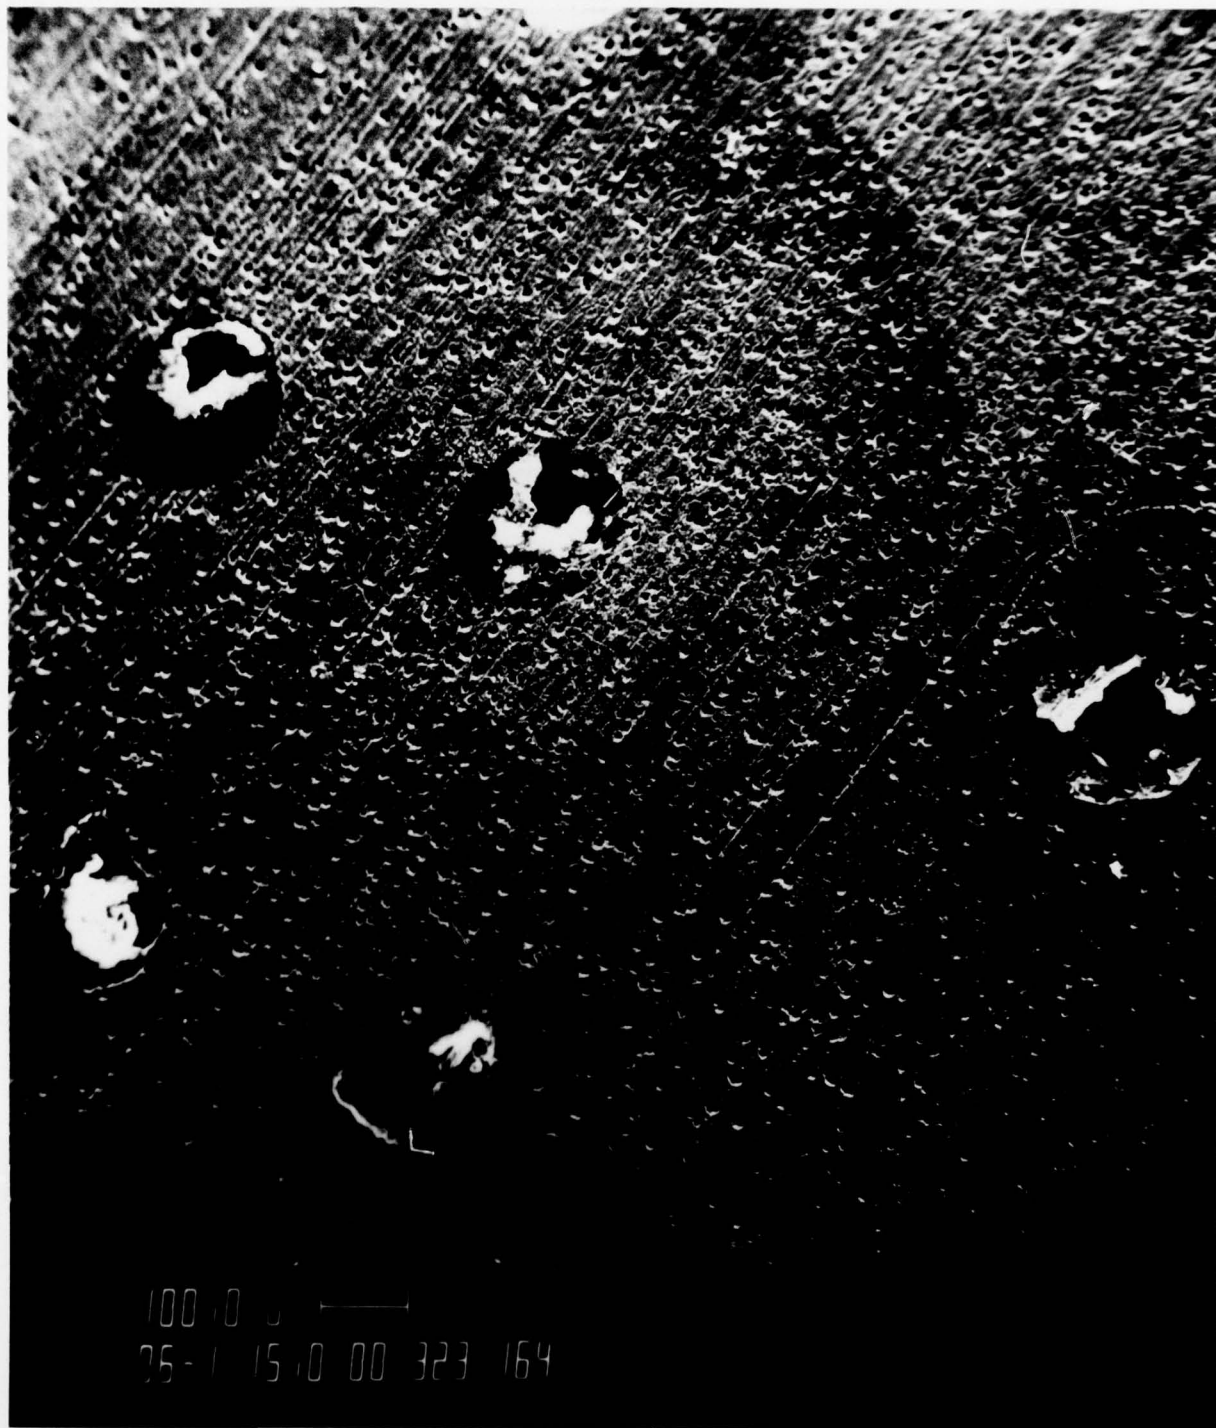
Figure 2. SEM Electron Micrograph of a Typical Pit Corrosion Area

Each specimen was placed individually in the corrosion solution and observed with the use of a binocular microscope. Corrosion was allowed to take place at open circuit potentials. Primary attack on each specimen was recognized at discrete points on the surface by the onset of a stream of bubbles. When the area under observation had initiated 3 to 5 pits the specimen was removed from the solution and rinsed with methanol, then distilled water and dried at 150°F under a heat lamp. What makes this corrosion solution particularly interesting is the fact that pure aluminum, aluminum oxide, and aluminum hydroxide are not readily attacked at room temperature. Therefore, the pitting that occurs will only take place through defects in the anodic oxide film formed on 2024 and 7075. A typical corrosion pit area (Figure 2) is shown in the SEM micrograph. The pit area is then marked and a chemical analysis performed on

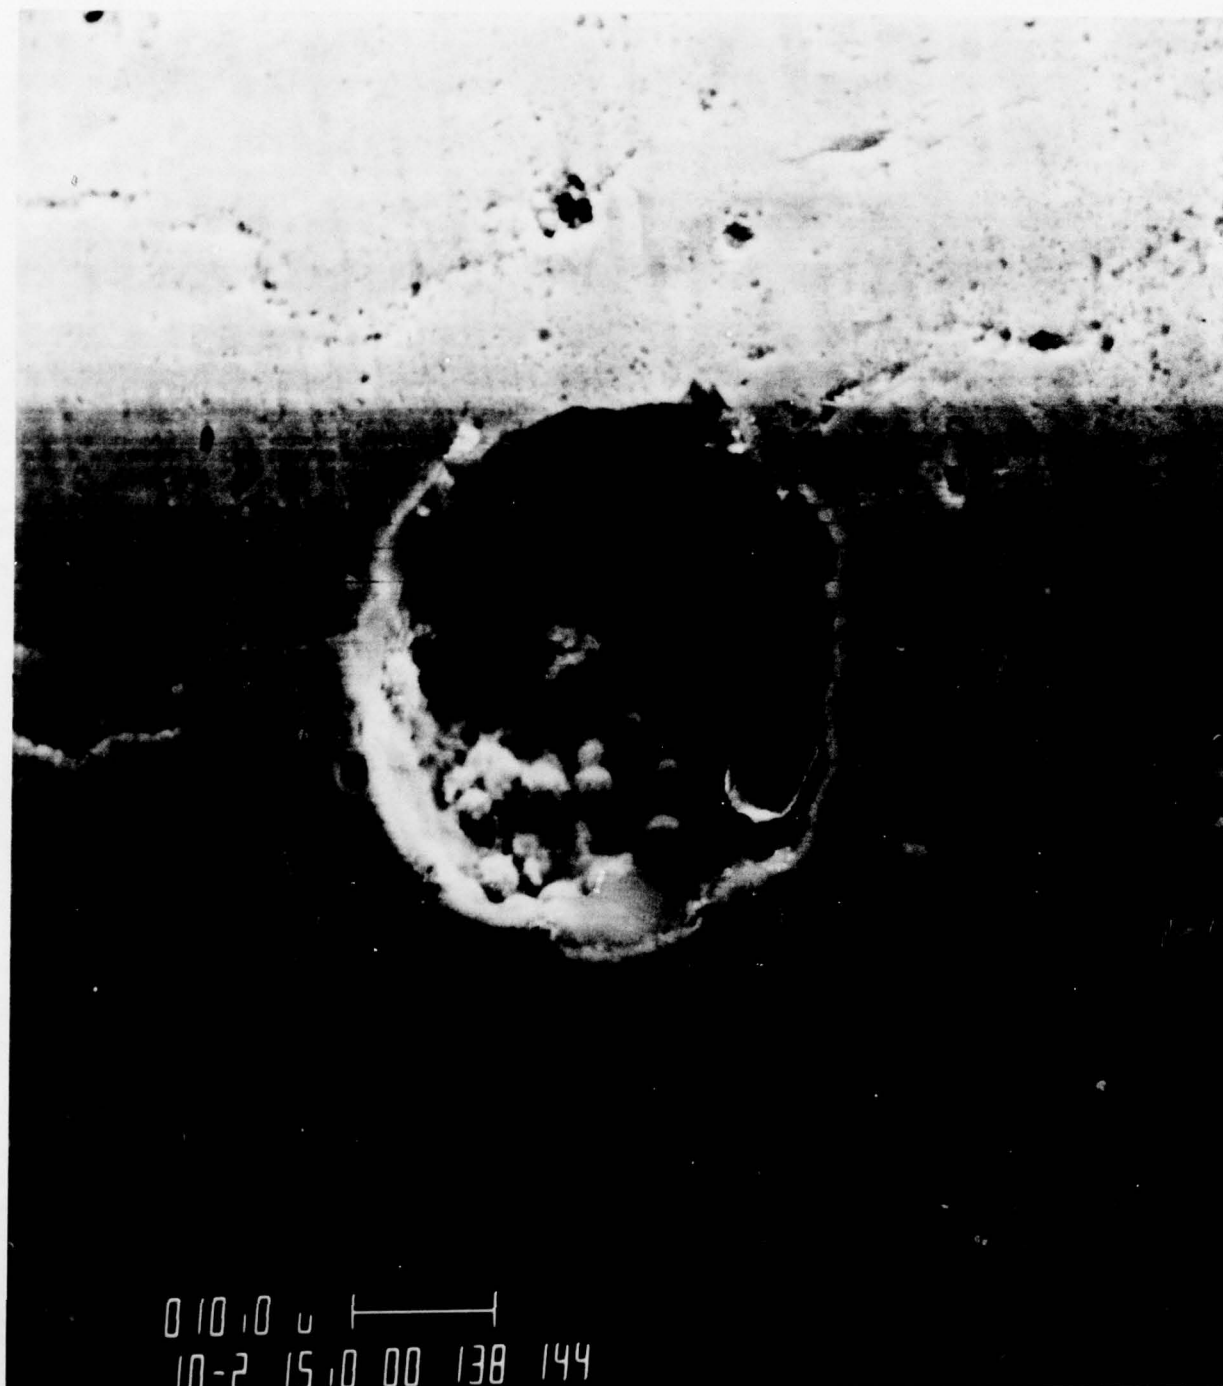
Figure 4. SEM Micrograph of a Pit Containing Spherical Growth Products

Figure 4 shows an SEM micrograph of a corrosion pit produced on 2024 aluminum. The pit in this case has no oxide film covering the area. There appear to be small spherical growth products at the bottom of this pit. The electron beam from our Auger spectrometer can be focused into this pit allowing us to obtain an elemental chemical analysis of this area. The data obtained from this pit (Figure 5) shows copper with a large peak to peak intensity with the amplifier sensitivity set at 4X. Some magnesium and manganese are also detected. A pit was formed on a 7075 aluminum specimen and analyzed (Figure 6). The elements copper, zinc, and magnesium were detected. 7075 aluminum contains approximately 5.5% zinc; however, only a small amount is detected in the pit. Auger data obtained outside a pit (Figure 7) was used as a reference point for the elements found within the pit. Elements of primary interest detected outside the pit, are aluminum and oxygen. Figure 8 is an x-ray image of the pit shown in Figure 4. The image depicts the data from the x-ray system set to accept energies for the element copper. The bright images indicate the presence of copper (Reference 8) in the spherical products at the bottom of the pit. Figure 9 shows a mosaic of micrographs. The upper right corner is an SEM electron picture of a pit generated on a 7075 aluminum specimen. The other three micrographs represent x-ray images. The upper left shows the

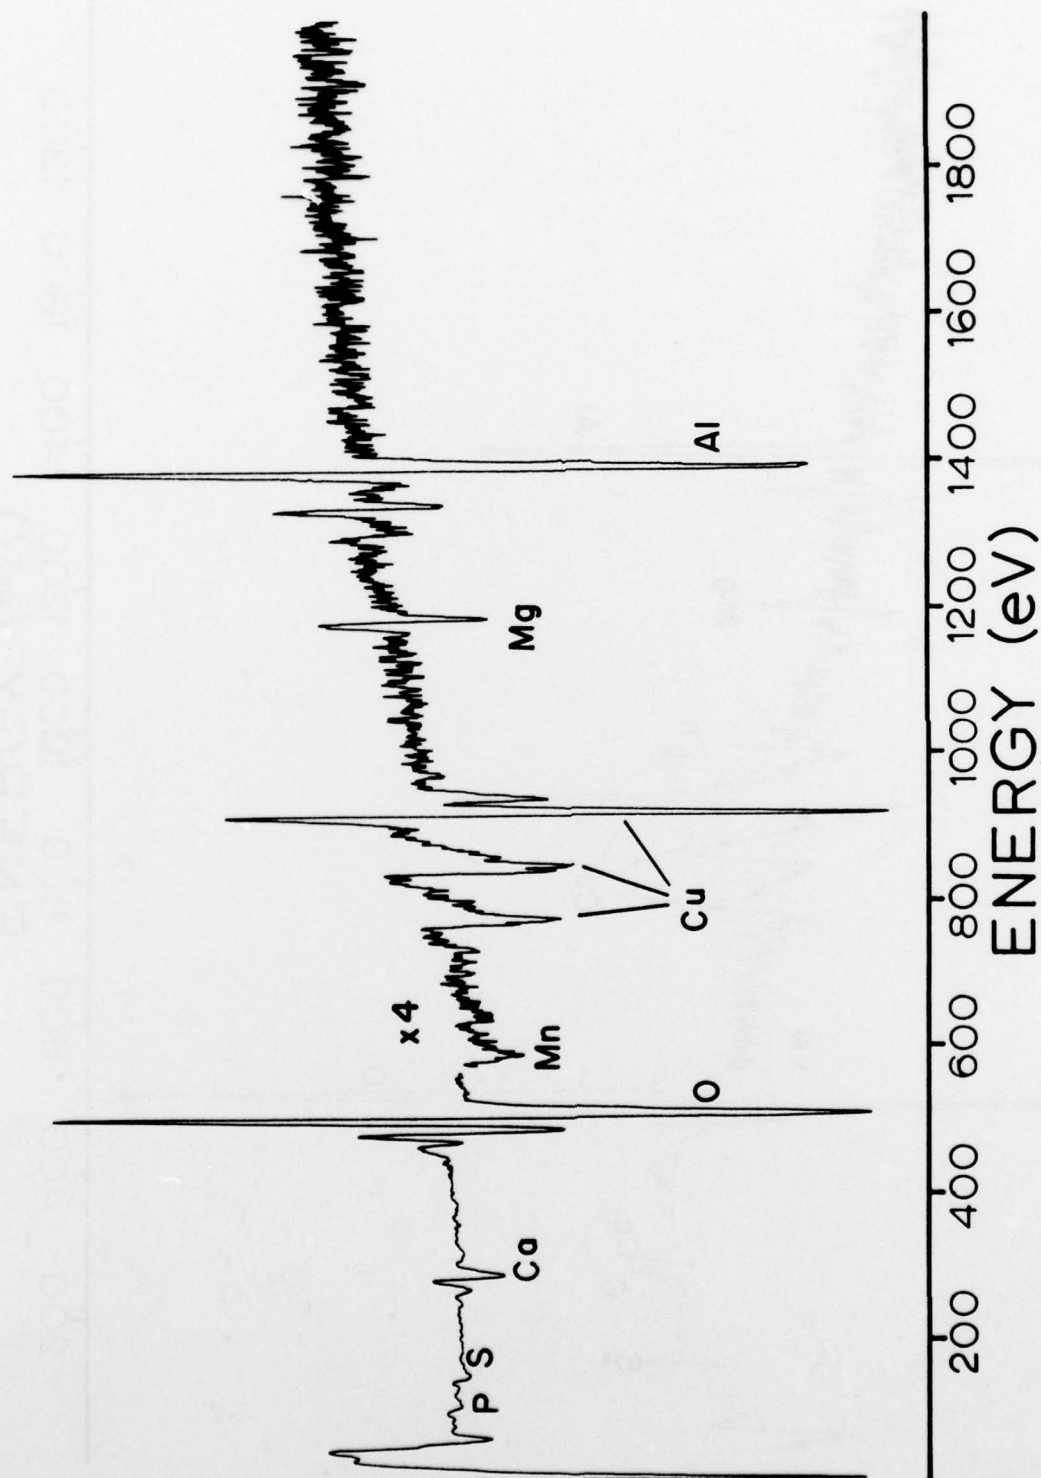
Figure 5. Auger Spectrum of a Pit on a 2024 Aluminum Specimen

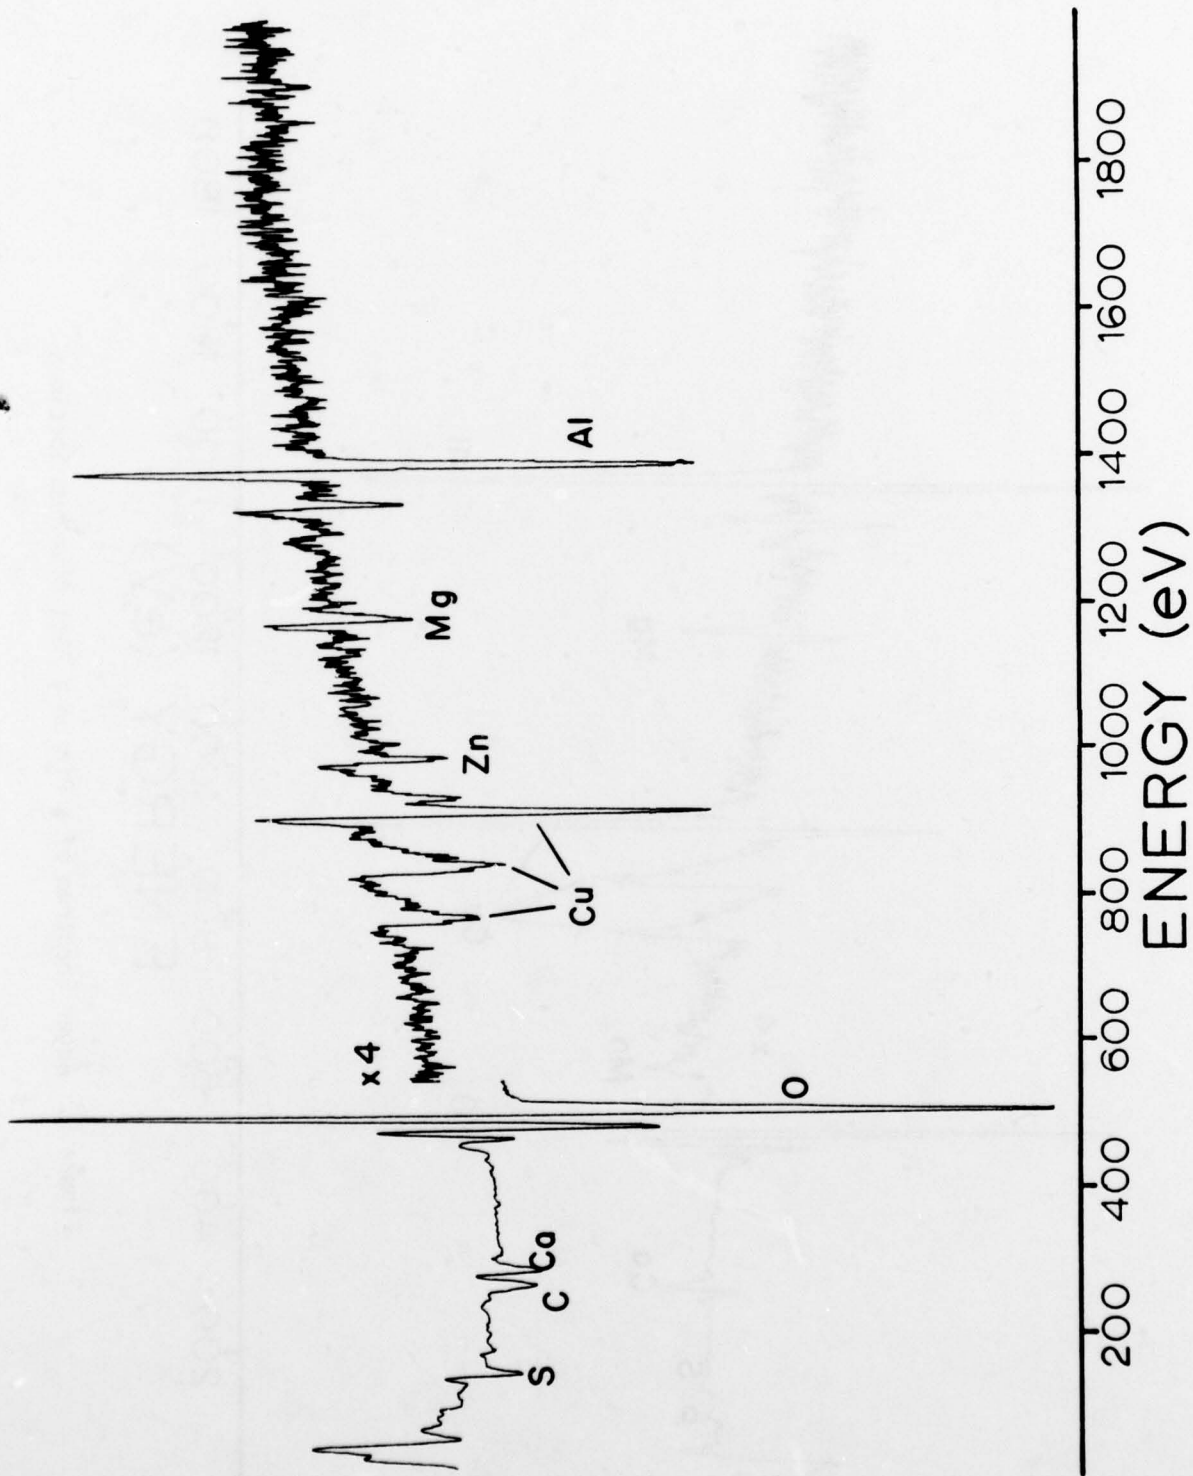
Figure 6. Auger Spectrum of a Pit on a 7075 Aluminum Specimen

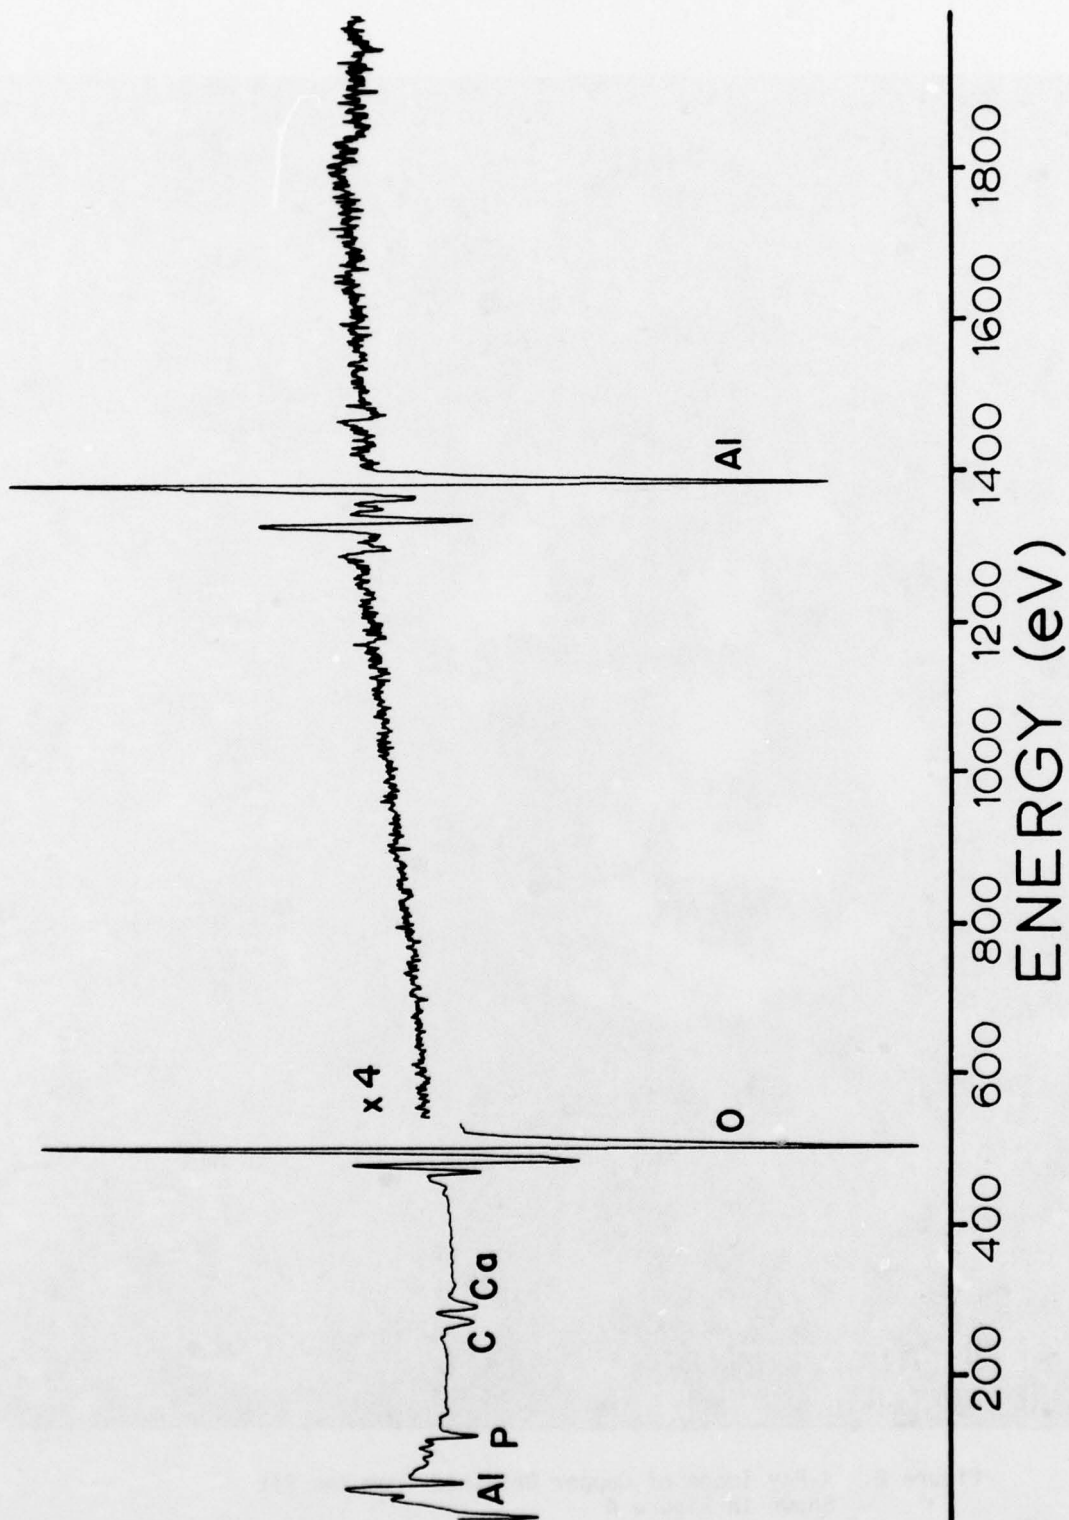
Figure 7. Auger Spectrum from the Surface Area Outside a Pit

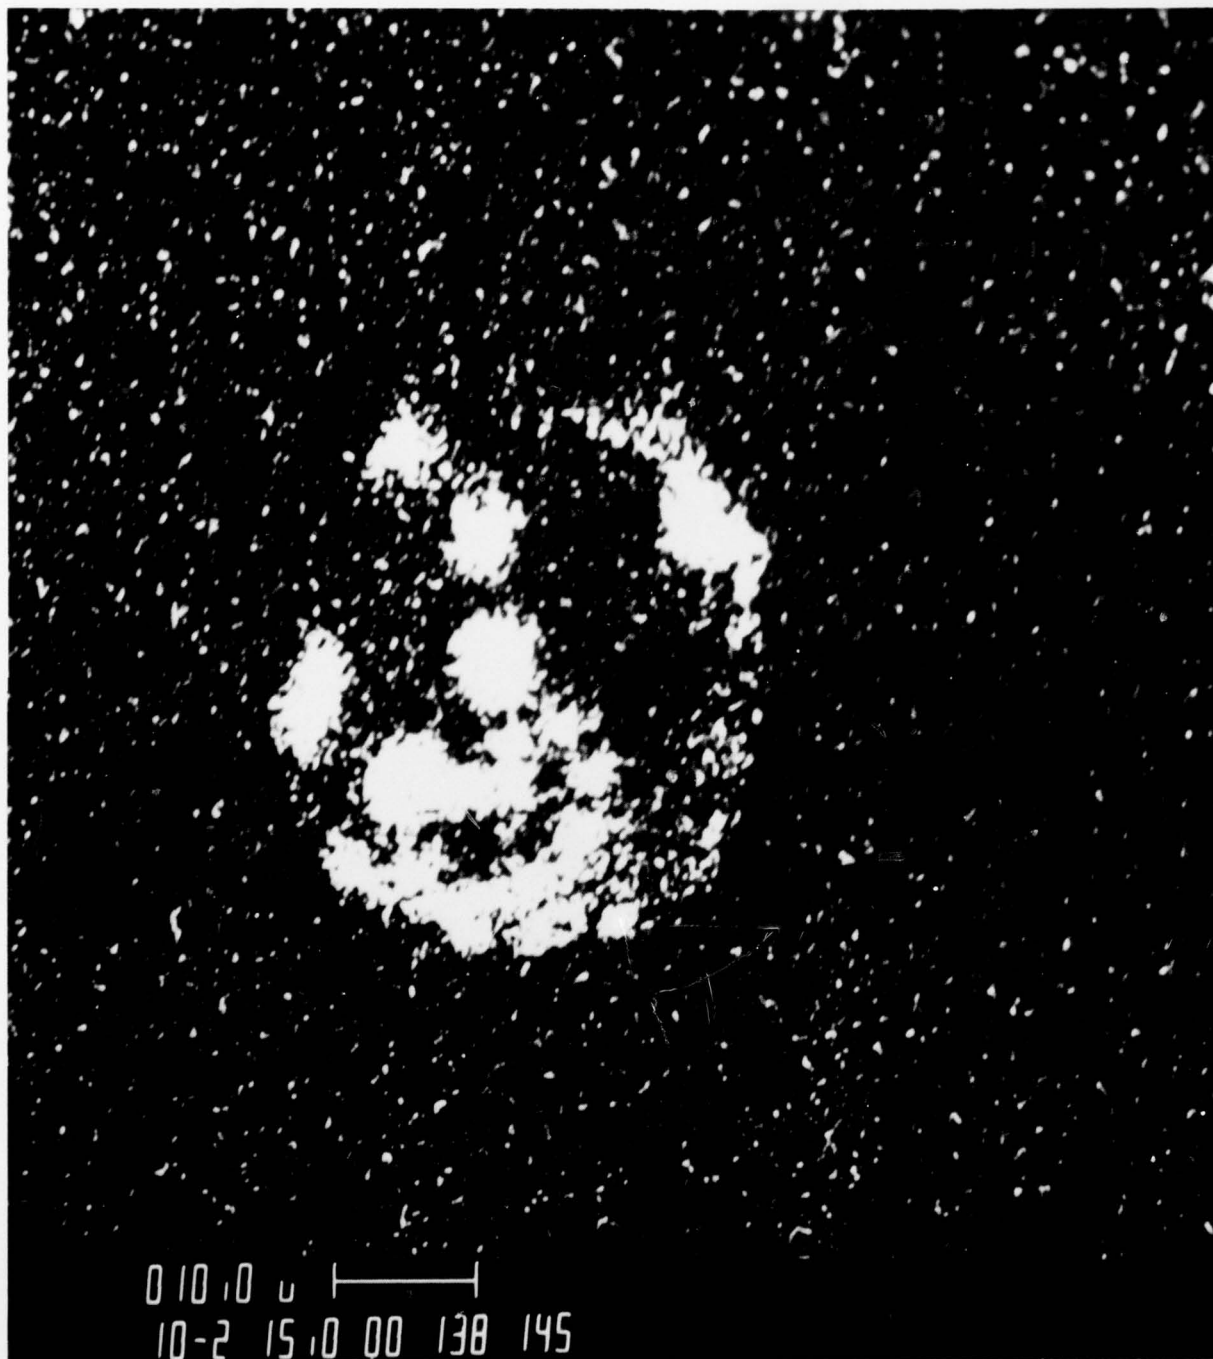
Figure 8. X-Ray Image of Copper Obtained from the Pit
Shown in Figure 4

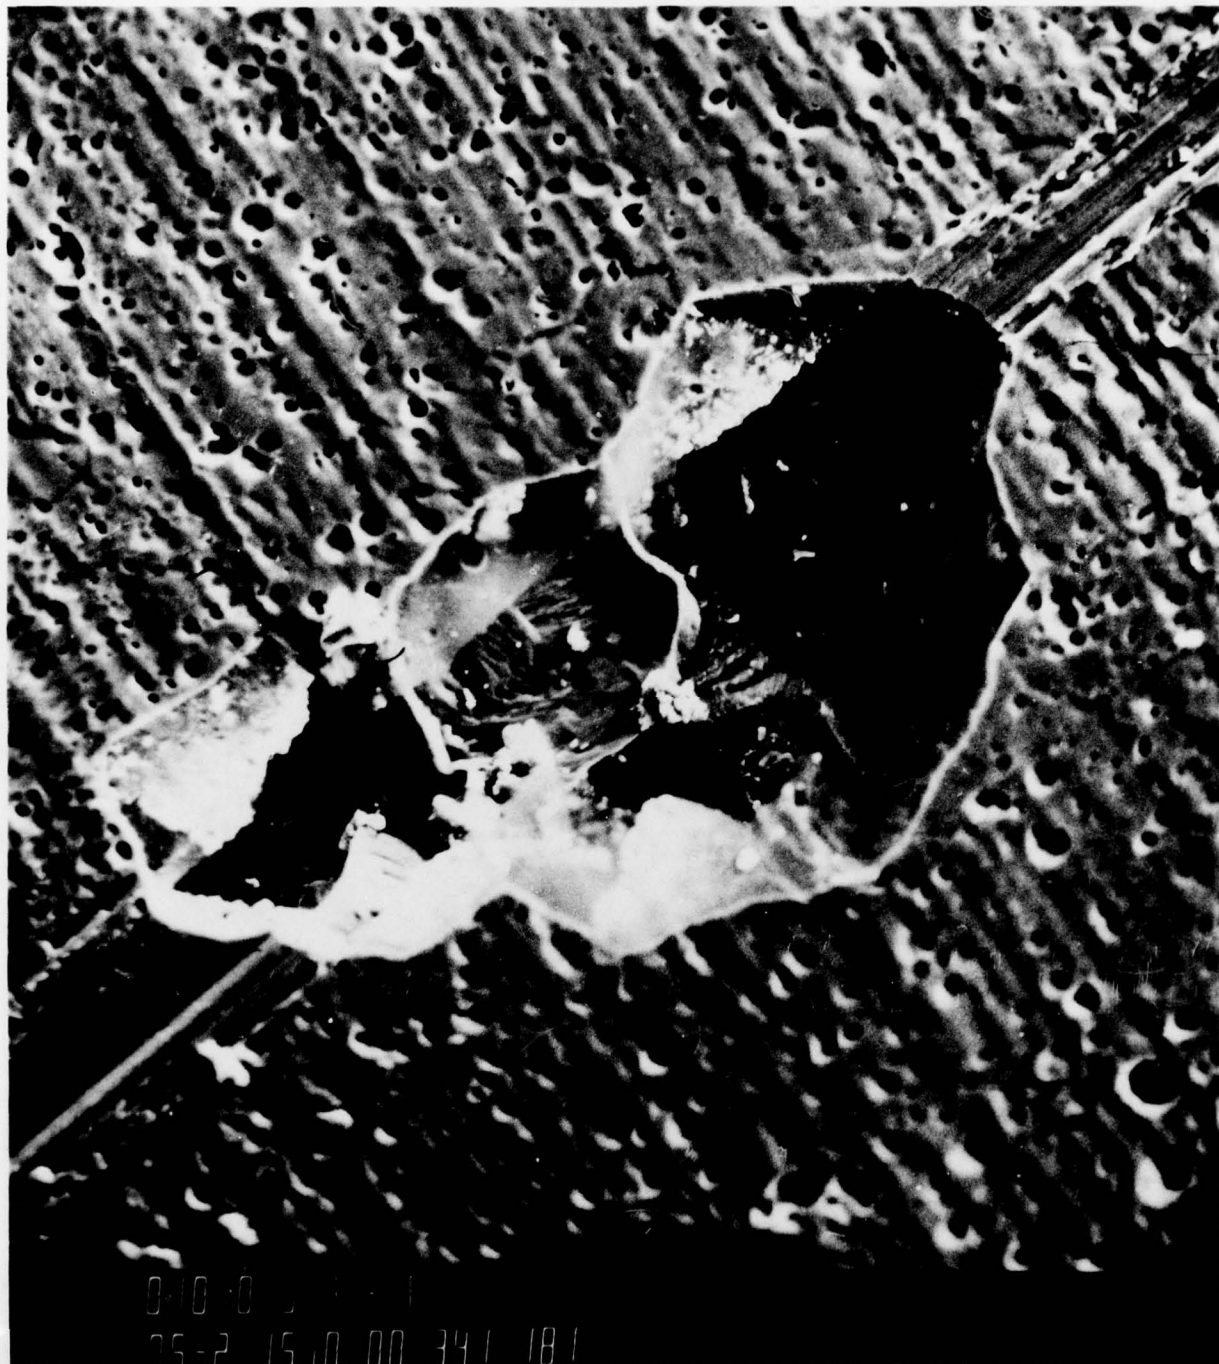
Figure 10. Corrosion Pit Formed on Clad 2024 Showing Preferential Etching of Pit

The clad specimens required a much longer time period (compared to the bare material) in the corrosion solution in order to start pit formation. This was expected since the corrosion solution reacts very slowly with a pure aluminum film* at room temperature. Examination of the pits that eventually occurred showed selective dissolution of certain grain boundaries. An SEM micrograph of one of these pits formed on the surface of 2024 clad aluminum is shown in Figure 10. A similar pit was obtained from a 7075 clad specimen (Figure 11). Neither x-ray energy data or Auger electron spectra detected any of the alloying constituents in the pit. Aluminum and oxygen were the only elements detected. The 7075 clad material was the first to pit. The 2024 clad specimen required a scratch to initiate a pit formation.

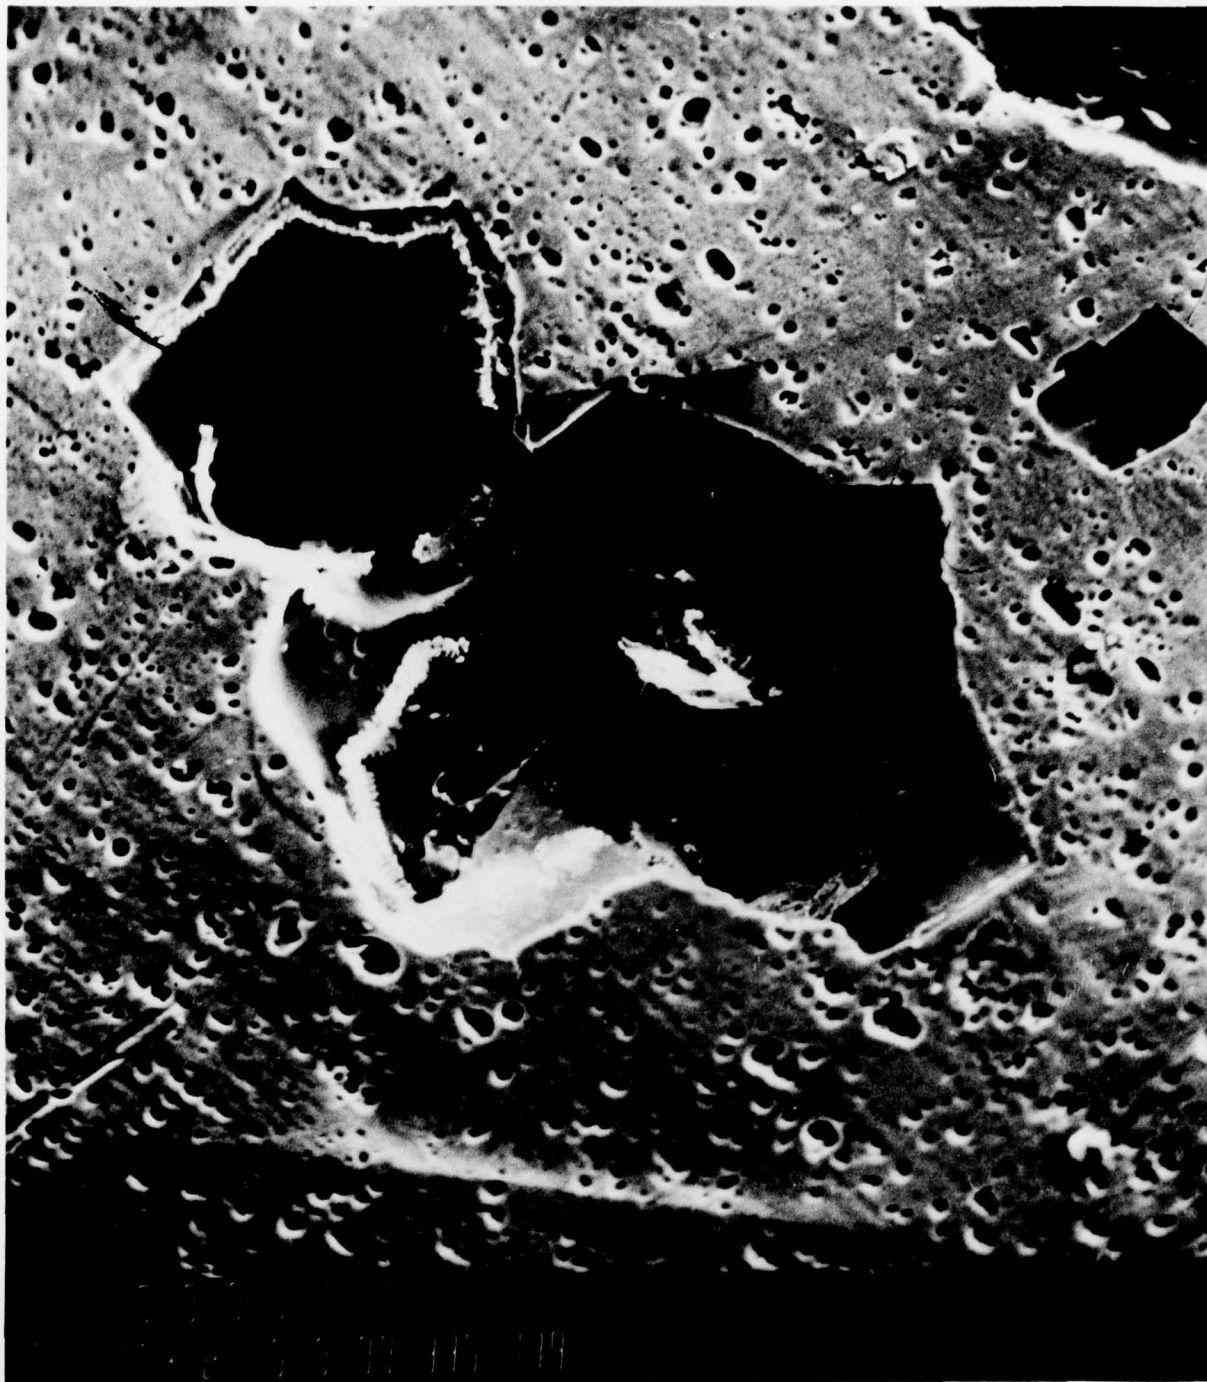
Figure 11. Corrosion Pit Formed on Clad 7075 Preferential Etching of Pit
